TO: CA/Director, Flight Crew Operations
THRU: CB/Chief, Astronaut Office
FROM: CB/Commander, STS-27
SUBJECT: STS-27 Flight Crew Report

STS-27 FLIGHT CREW REPORT

Classified aspects of this mission are discussed in a classified supplement covering the primary payload portion of the mission. This report deals with the major crew observations, recommendations, and significant Orbiter systems problems encountered during STS-27 training and flight.

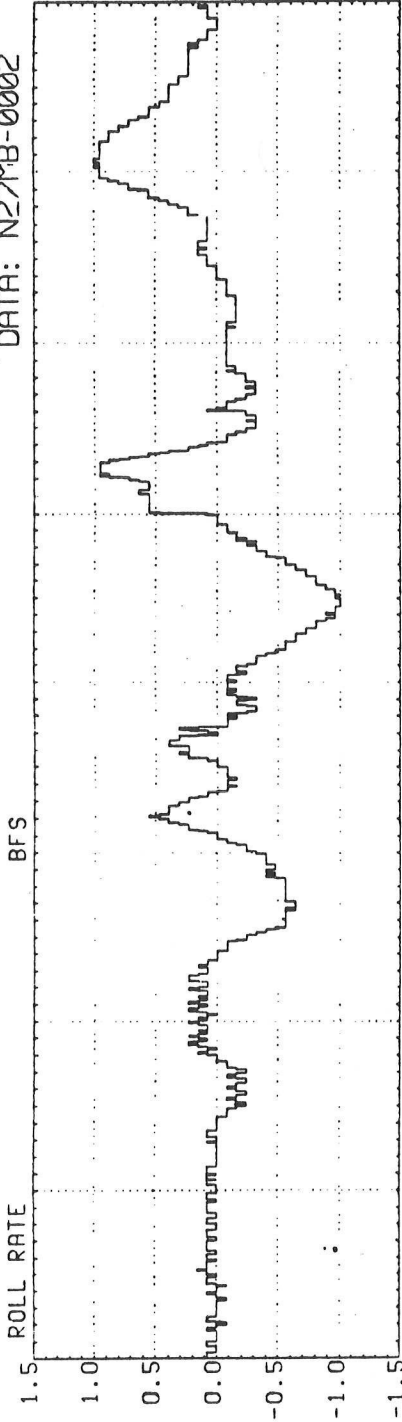
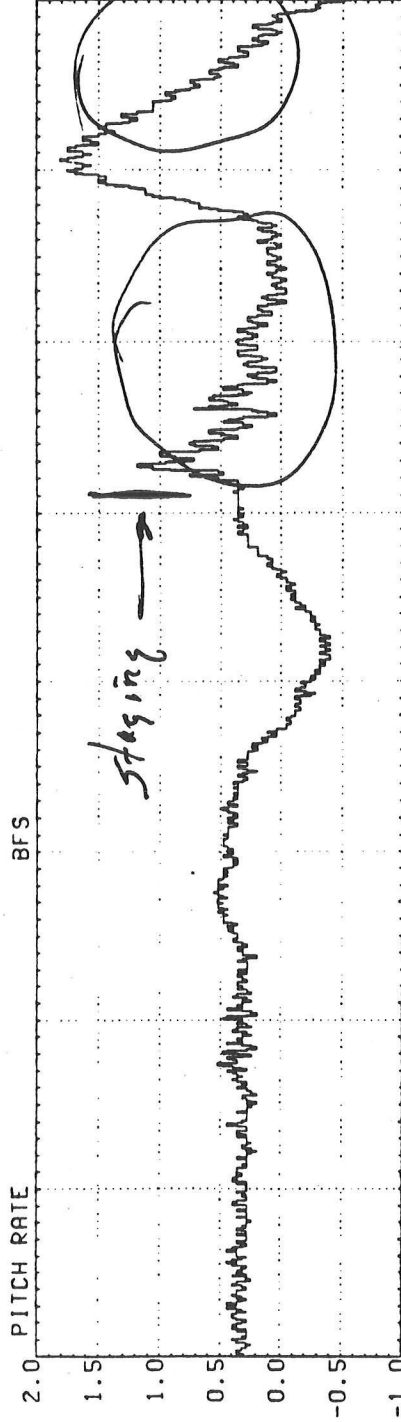
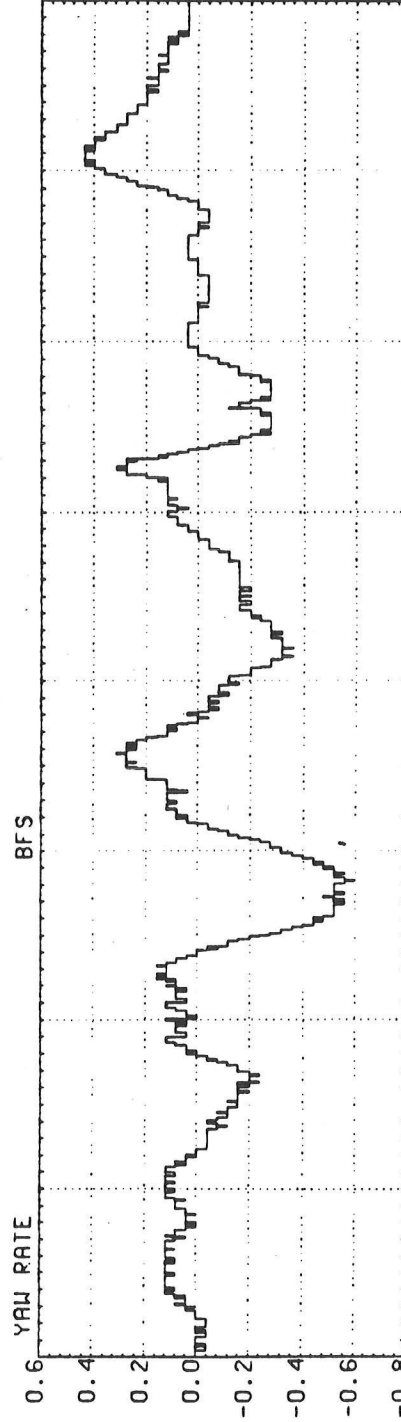
FIGURE 1

[REDACTED]
BFS BODY RATES

- VIBRATION CAUSED BY REPAIRS
- FROM 05:50:00
- AUTO TRIM HAS SOME NEGATIVE

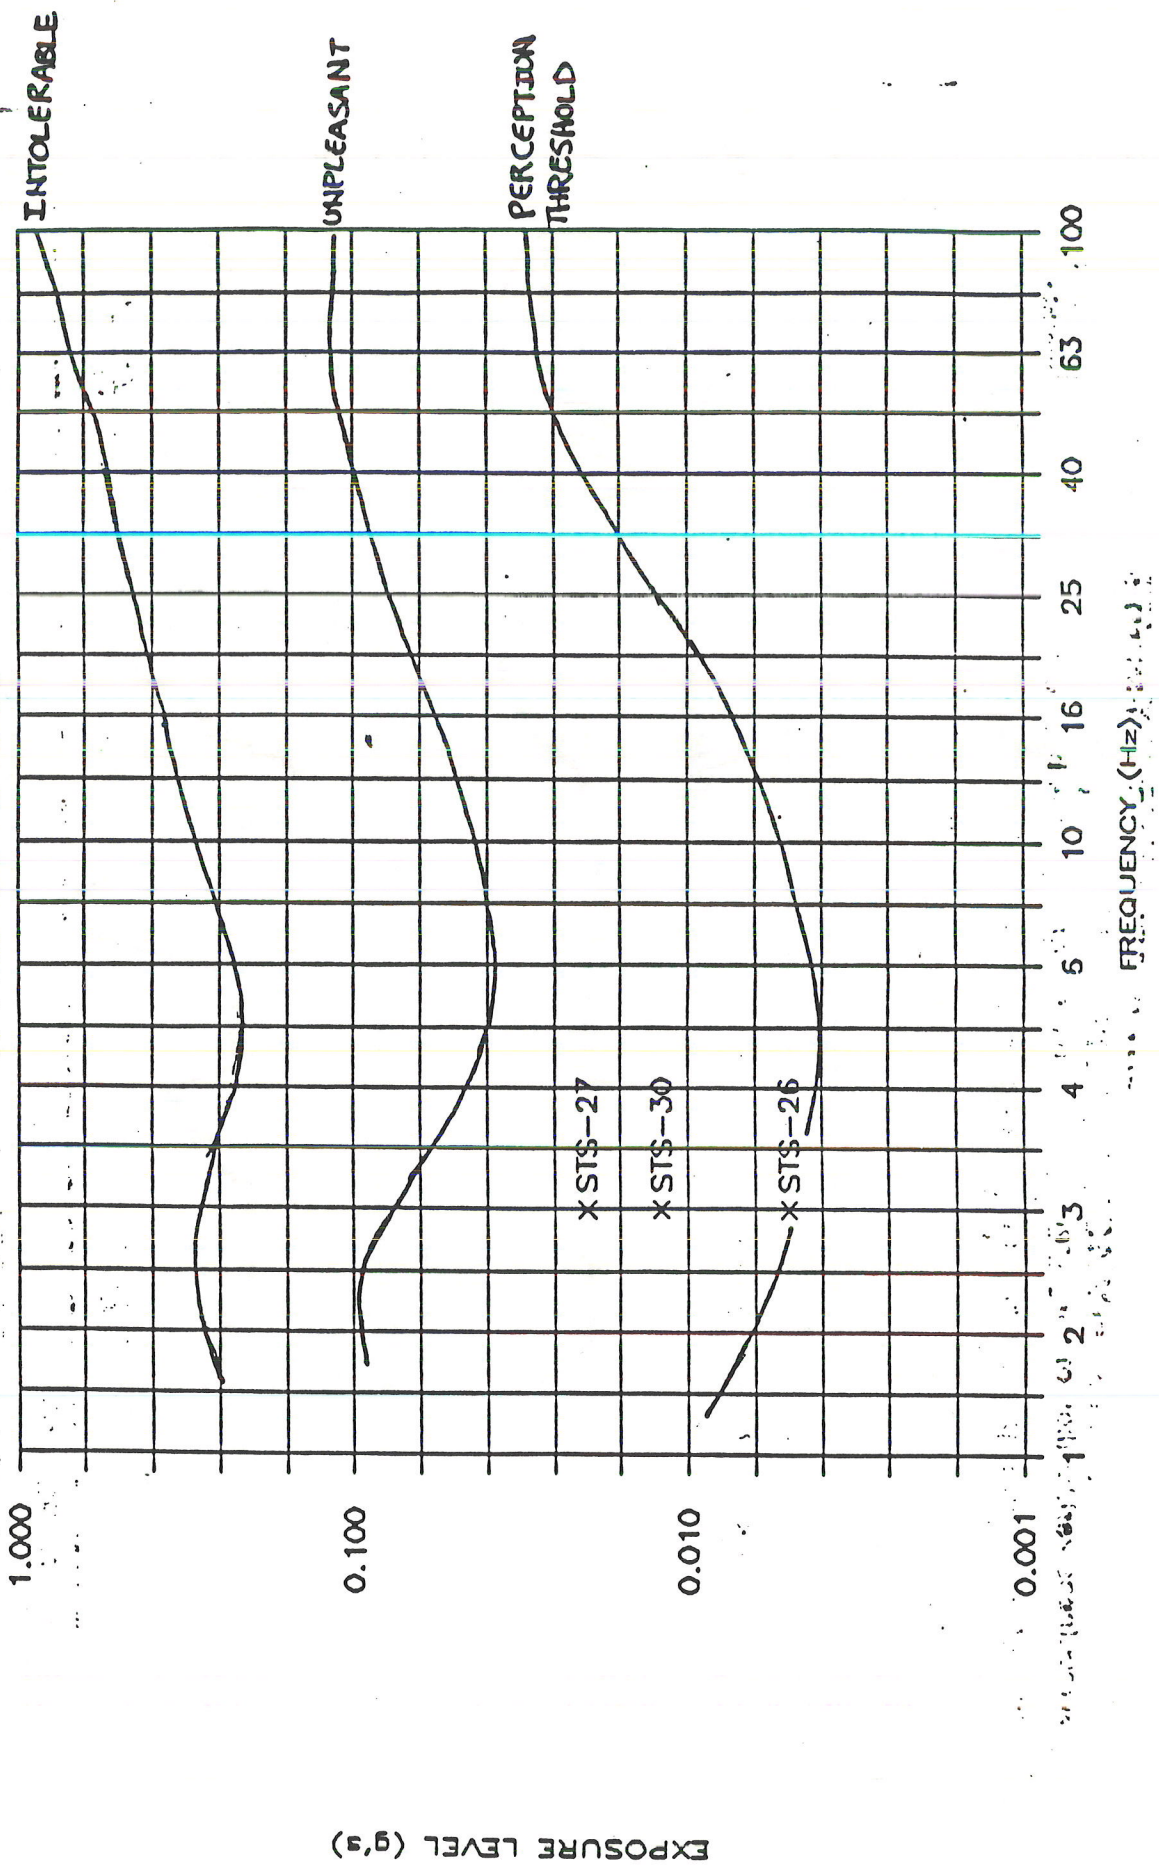
FIGURE 2

SUBJECTIVE HUMAN RESPONSE TO VIBRATION

PREDICTED RESPONSE

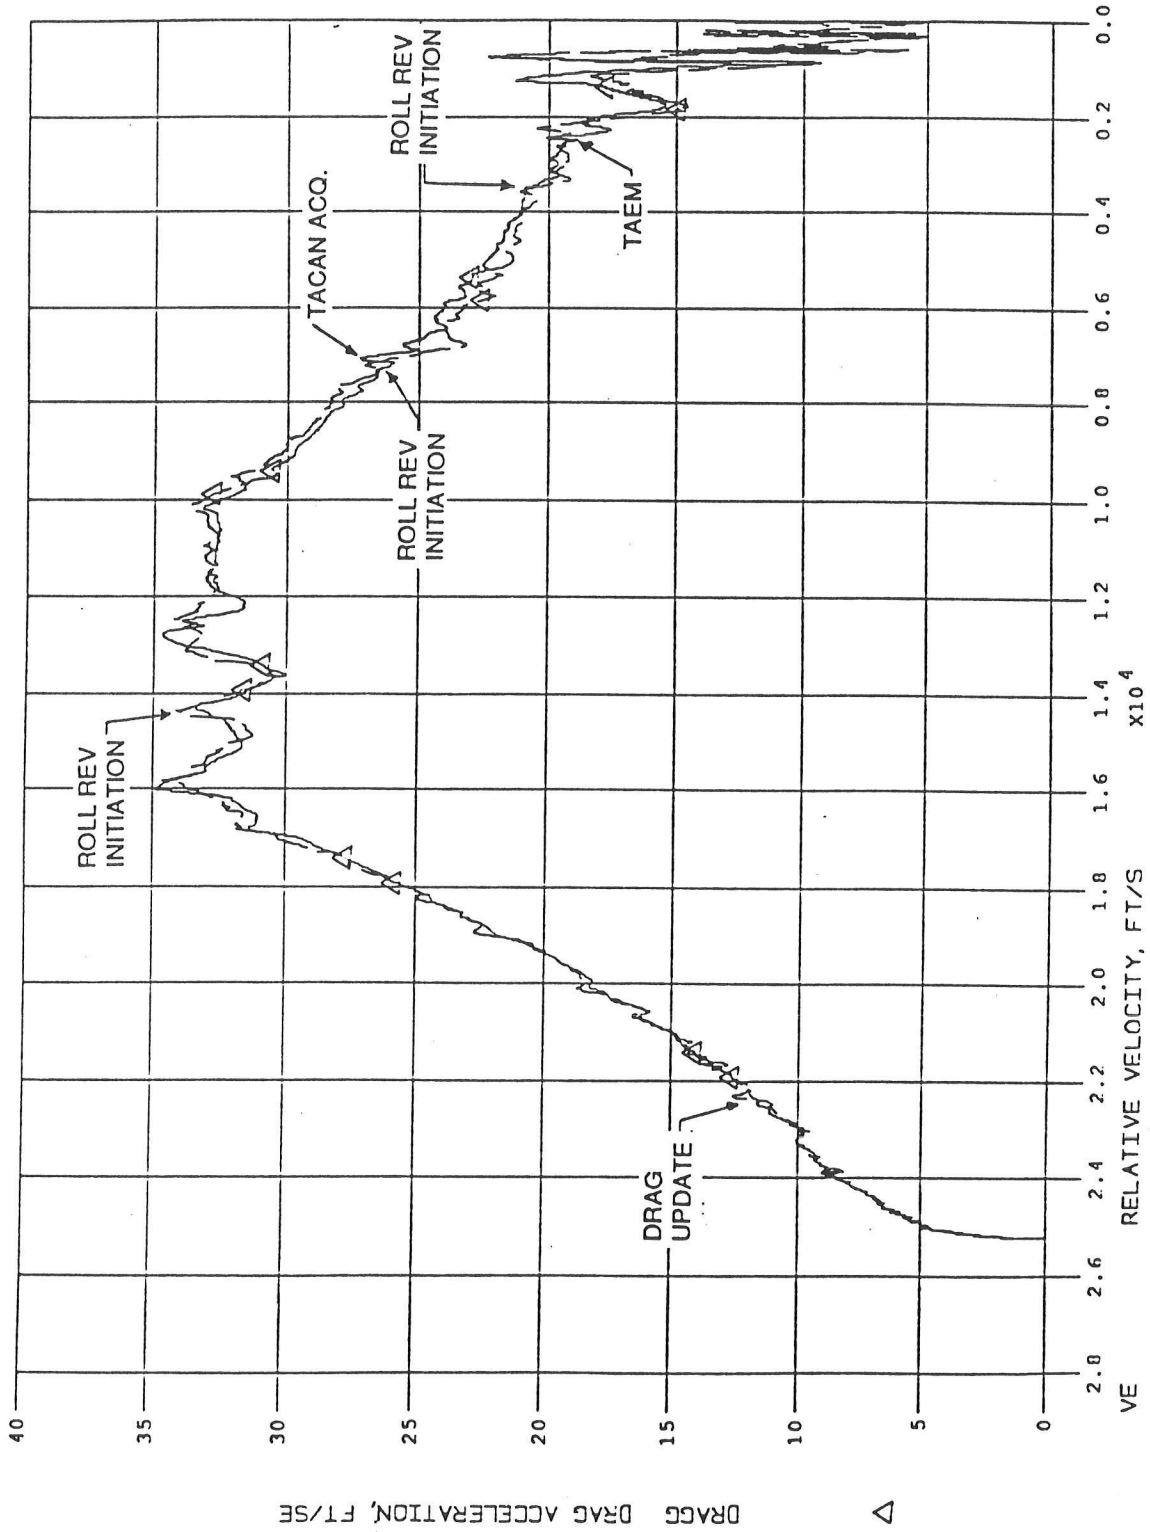
FIGURE 3

POSTFLIGHT / SVDS RE-CREATION COMPARE

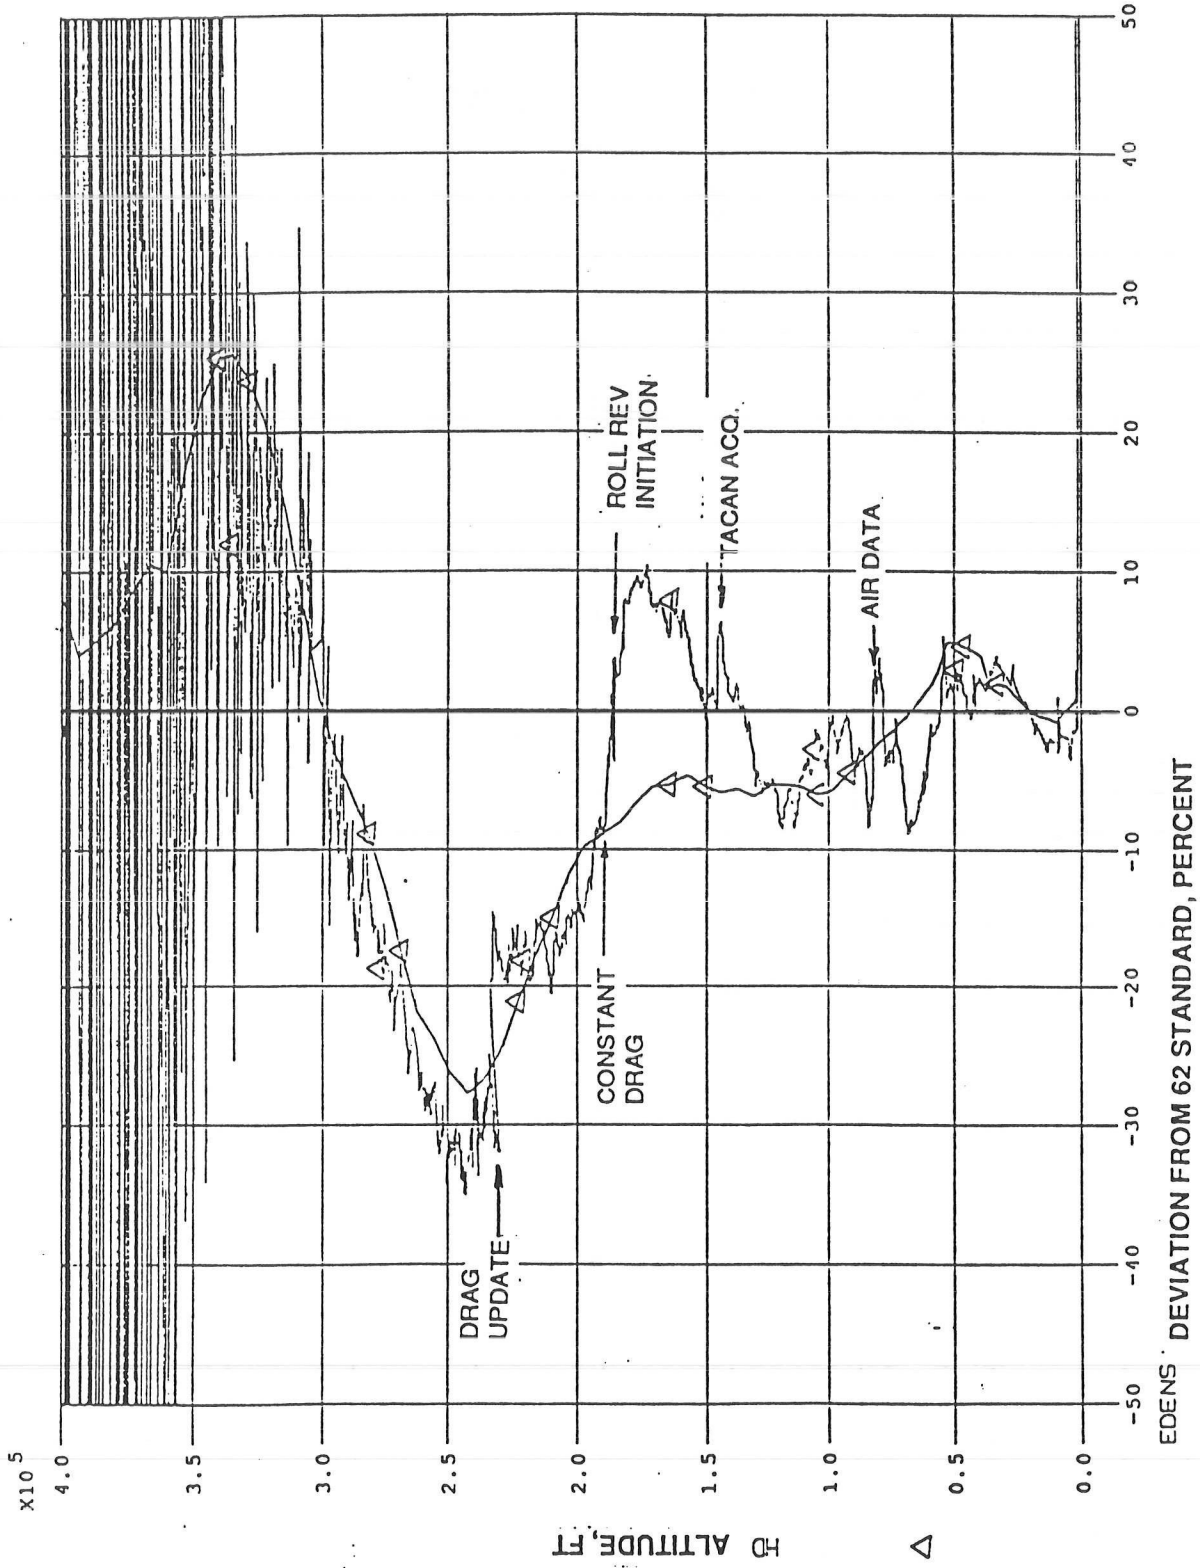
FIGURE 4

STS-27 DENSITY COMPARED TO DECEMBER MONTHLY MEAN

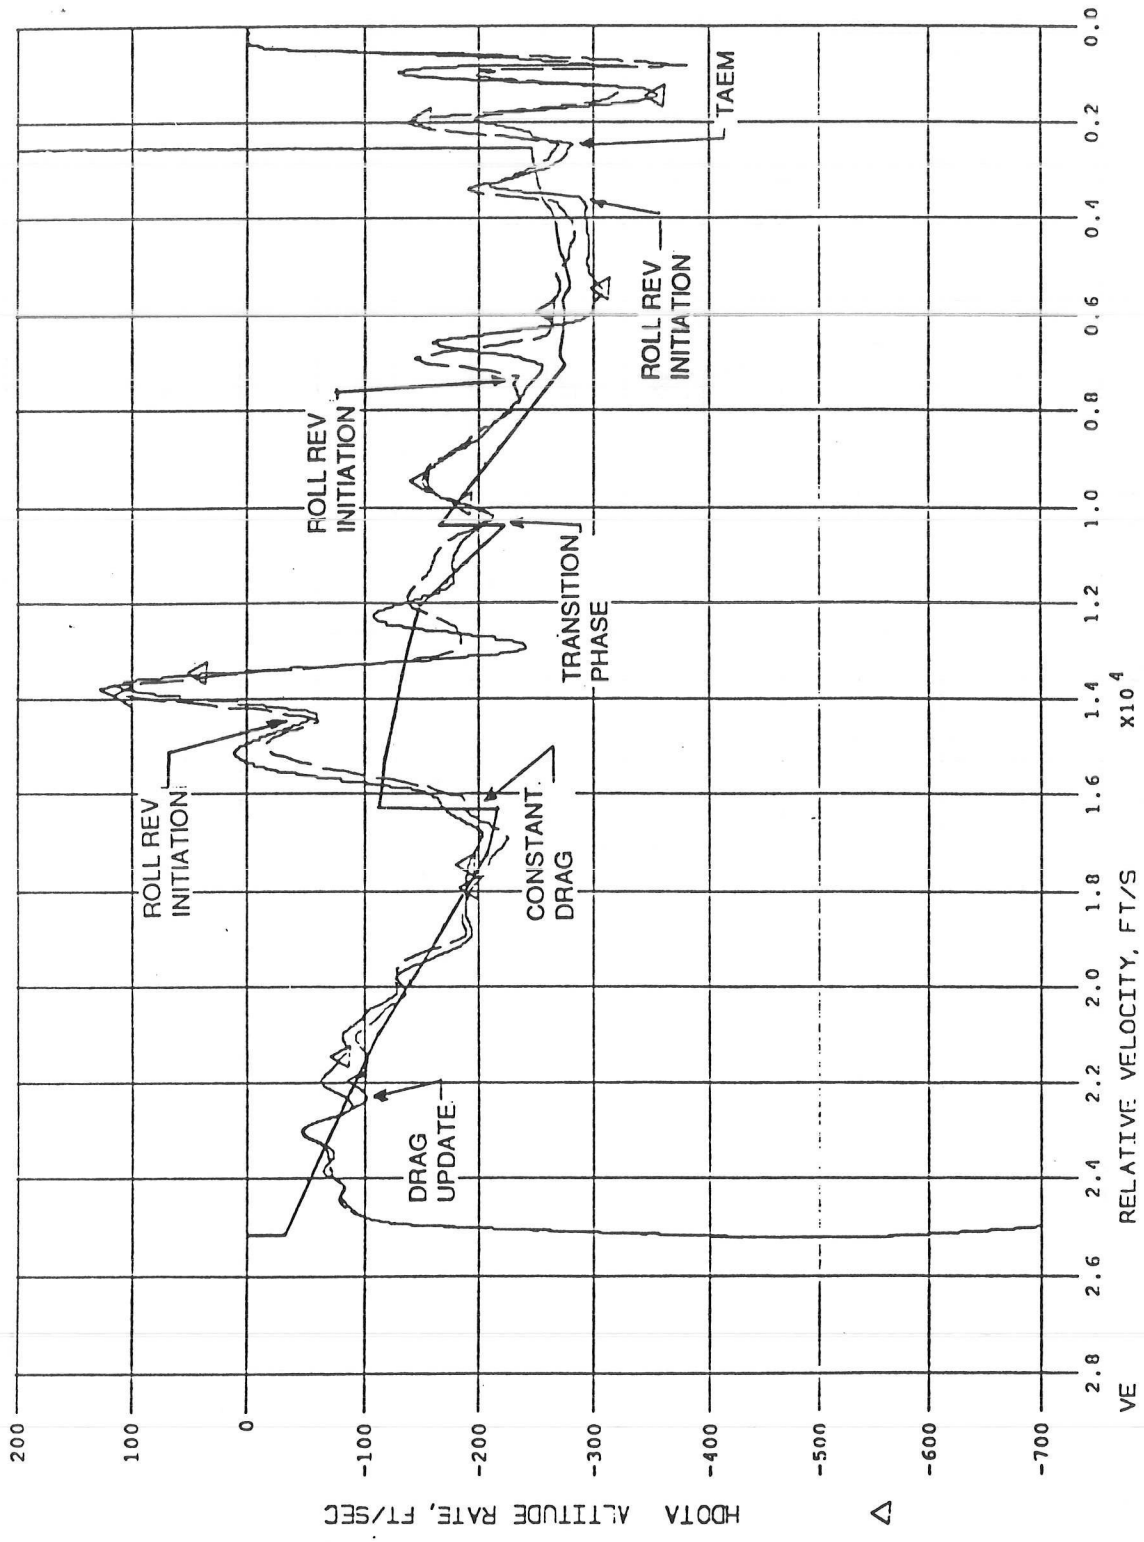
FIGURE 6

POSTFLIGHT / SVDS RE-CREATION COMPARE
